Safety Inspection Report

Annual Inspection

Recreation Field

Box Parish Council

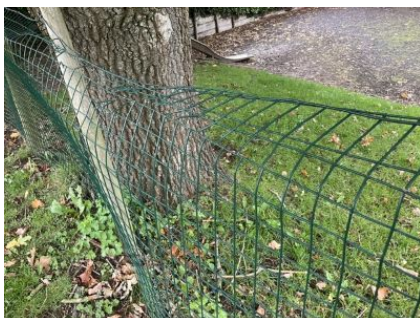
Fencing

Minor repairs are needed.

Repair.

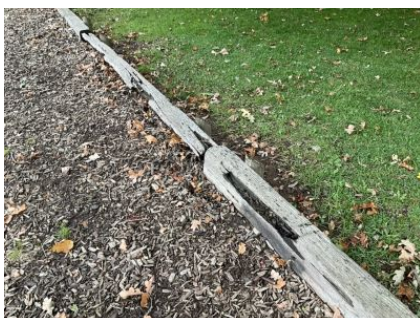
General Surface

Timber is decayed.

Replace affected parts.

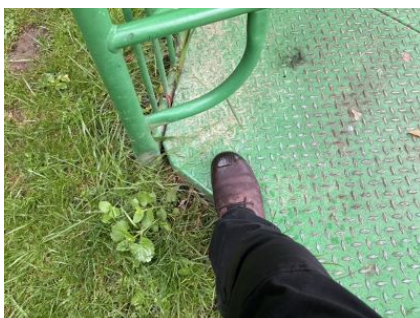
Shelter

Fixtures loose or missing.

Tighten/replace.

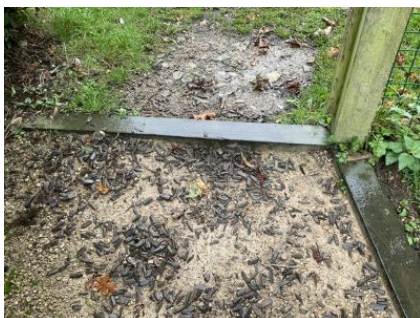
Gates - Pedestrian

Description	Tasks	Risk score
Trip points on the surface.	Make level.

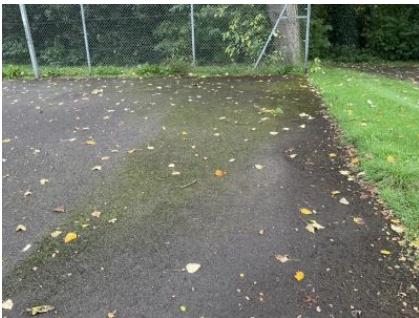
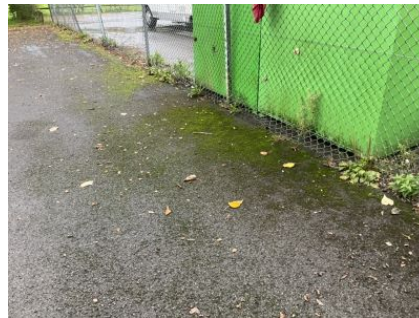
Minor repairs are needed.

Repair.

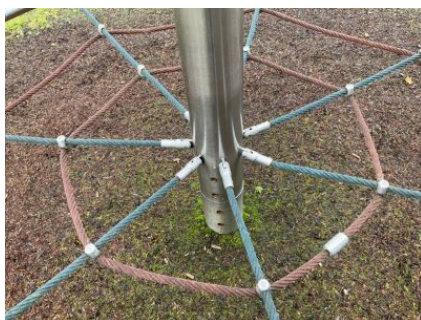
Climber - Rota Web

Fixtures loose or missing.

Tighten/replace.

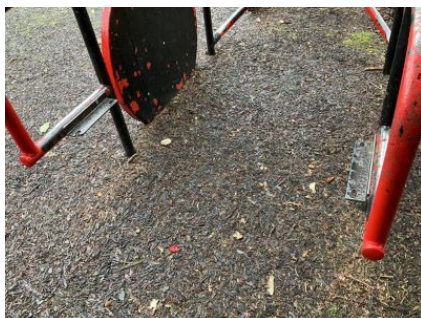
Climber - Train

Item has some parts missing.

Replace the missing parts.

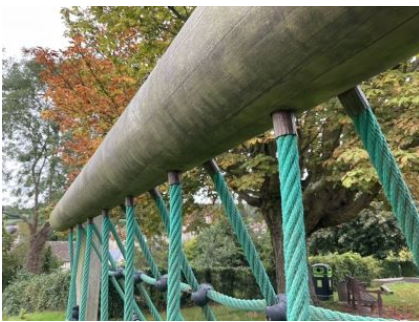
Climber - Up & Over

Check end of rope connections for corrosion.

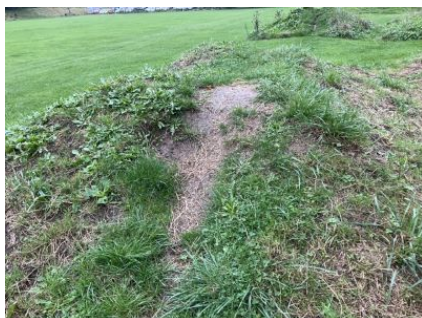
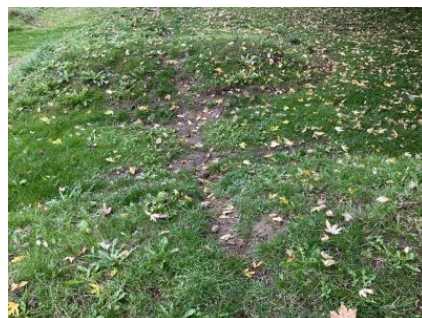
Cycle - BMX Track

Description	Tasks	Risk score
Ground erosion present.	Repair the worn areas.

Repair the worn areas.

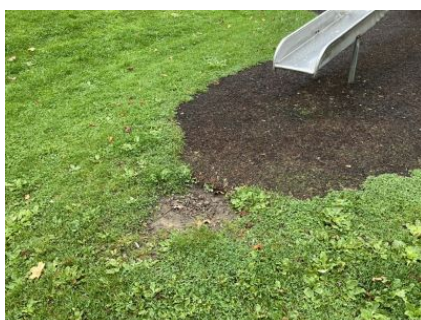
Multiplay

5
Ground erosion present.	Repair the worn areas.

Repair the worn areas.

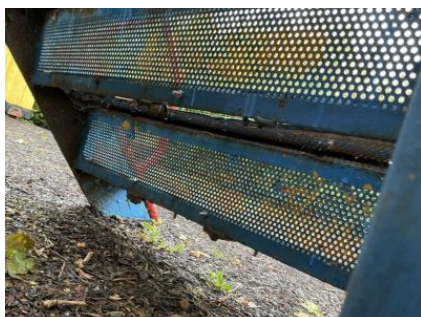
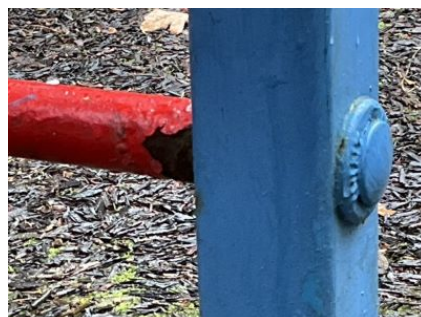
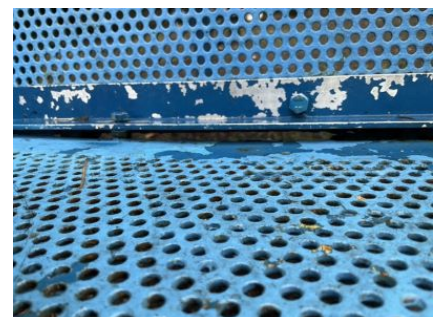
Multiplay - Toddler

Item has corrosion.

The blue steps are very corroded with sharp edges underneath. Movement in the steps. Corrosion in the frame. The repair does not support the step.

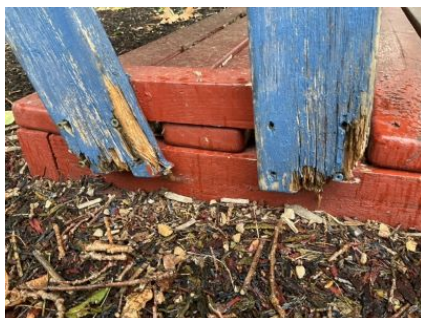
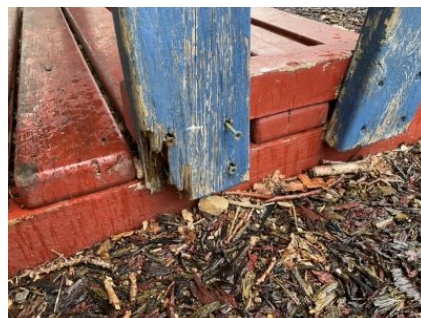
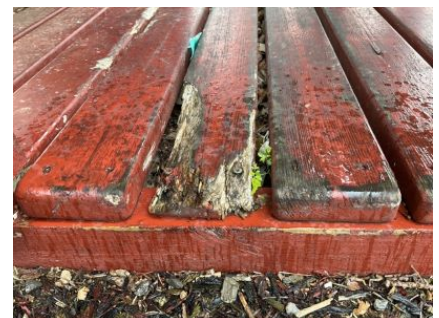
Play Hut

Minor repairs are needed.

Repair.

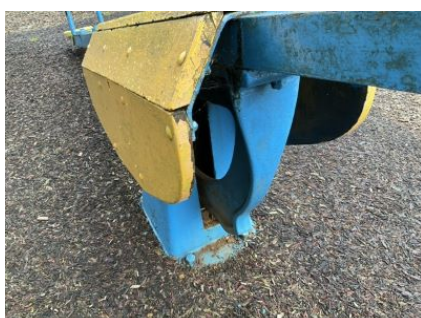
Rocker - Seesaw

There are crushing points in the open mechanism. Replace the item.

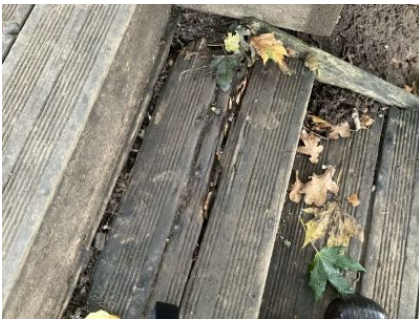
Timber is decayed.

Replace affected parts.

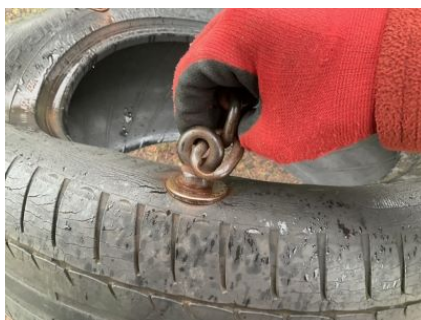
Swing - Cantilever

Some chain wear.

Replace end links.

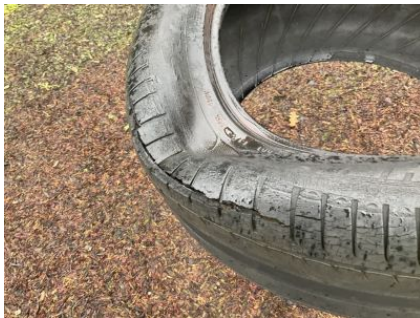
Fixtures loose or missing.

Item is damaged.

Replace.

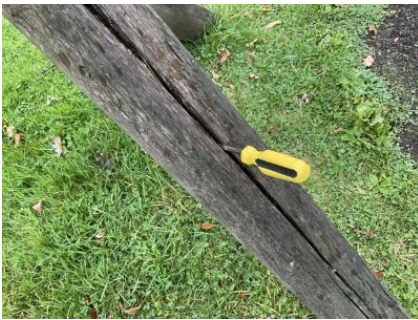
Timber is decayed.

Soft spots in air cracks.

We recommend resistograph testing to determine the internal condition of the timber. We can undertake this testing at additional cost. Please contact us for details.

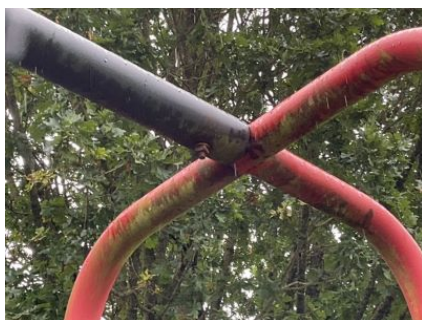
Swing - Junior - 1 Bay 2 Seat - Large

Fixtures loose or missing.

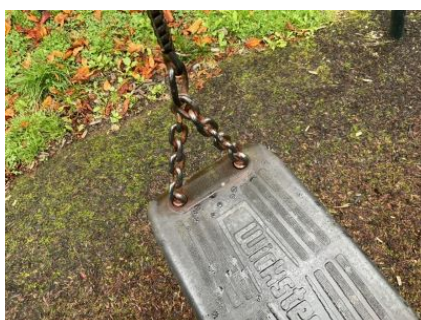
Swing - Junior - 1 Bay 2 Seat - Smaller

Some chain wear.

Monitor for further deterioration and replace before 40% wear.

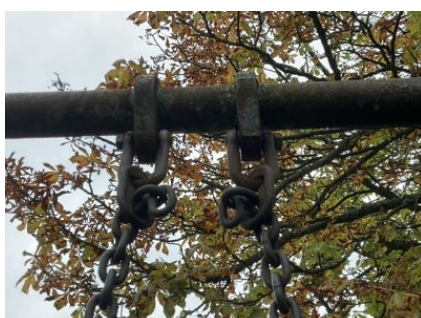
Swing - Mixed - 1 Bay 2 Junior 2 Toddler Seat

There is wear in the bushes.

Remove shackle bolt and check bush and shackle pin wear, replacing as necessary.

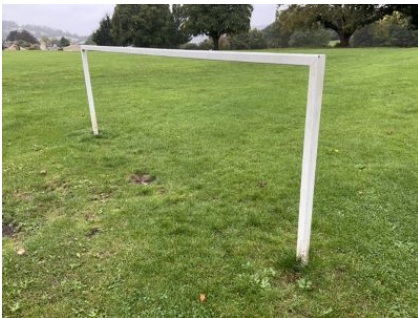
Football Goal - Youth, Small-sided, Mini-Soccer or Futsal

Loose in ground.
