Safety Inspection Report

Annual Inspection

Recreation Field

Box Parish Council

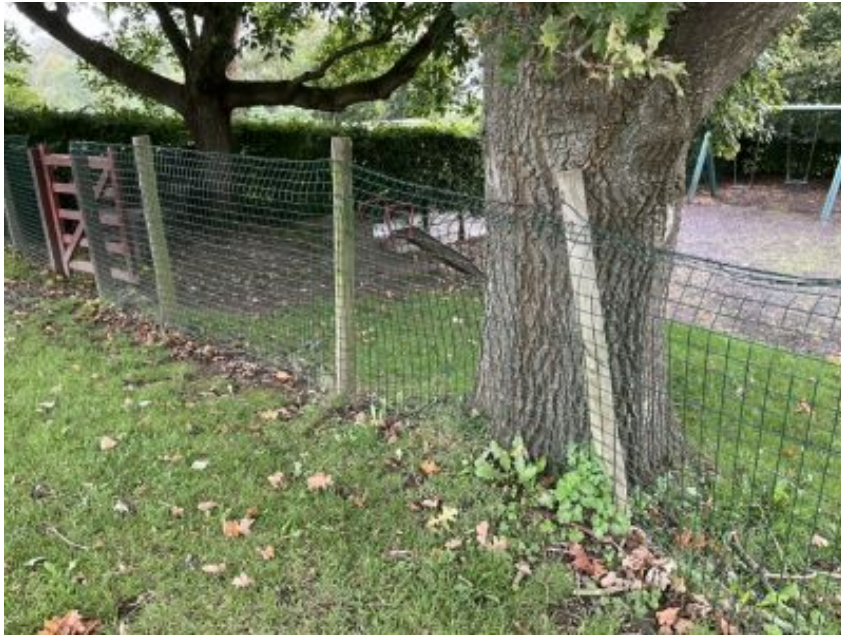
Fencing

Minor repairs are needed.

Repair.

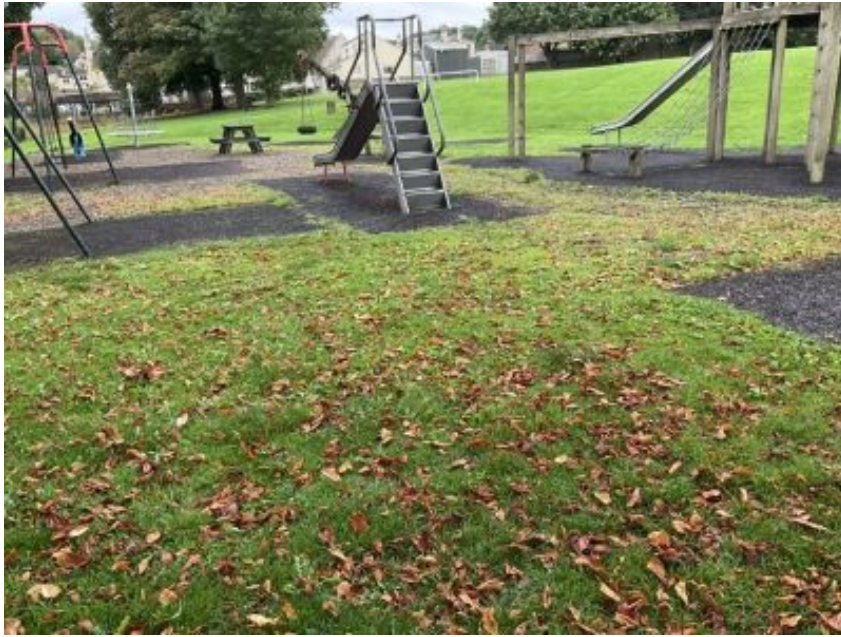
General Surface

Timber is decayed.

Replace affected parts.

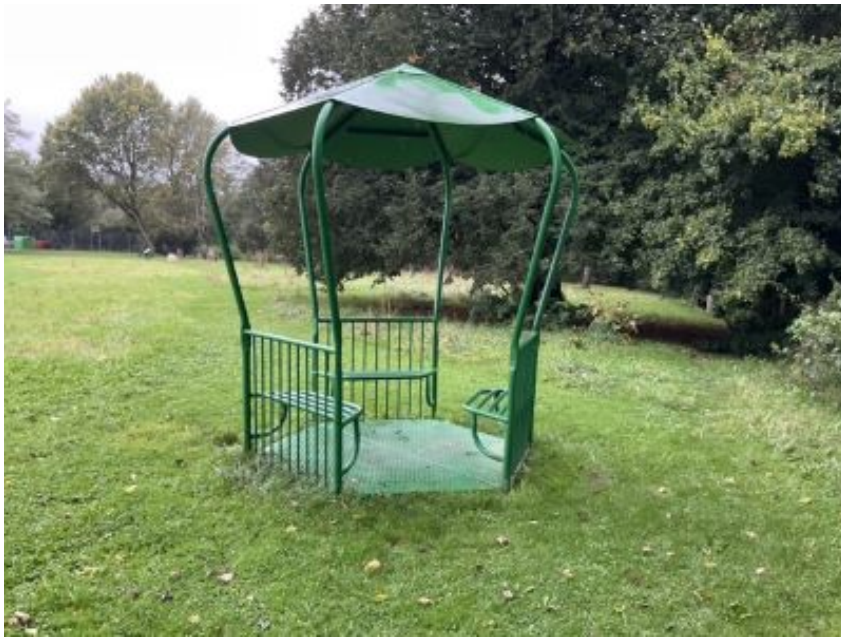
Shelter

Fixtures loose or missing.

Tighten/replace.

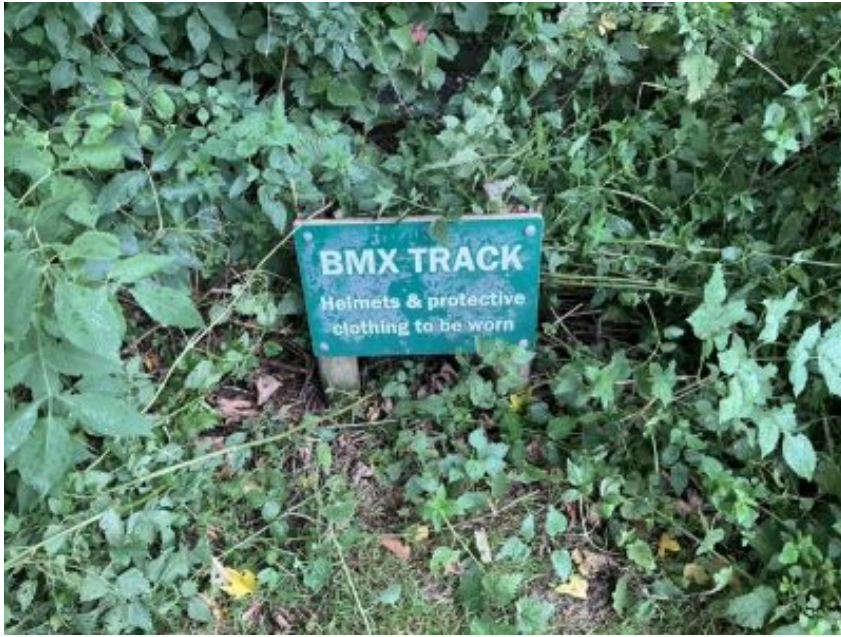
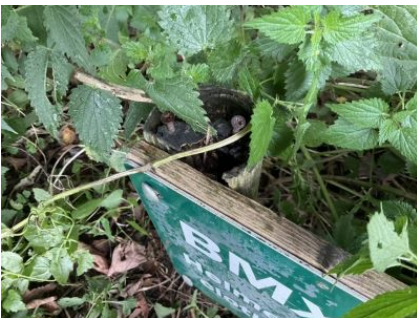
Signage - BMX

Timber is decayed.

Replace affected parts.

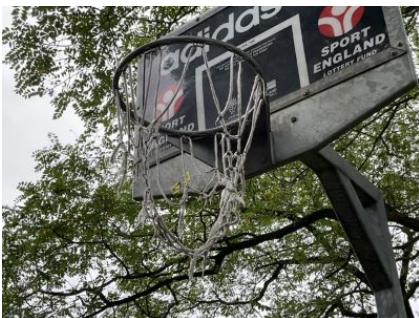
Minor repairs are needed.

Repair.

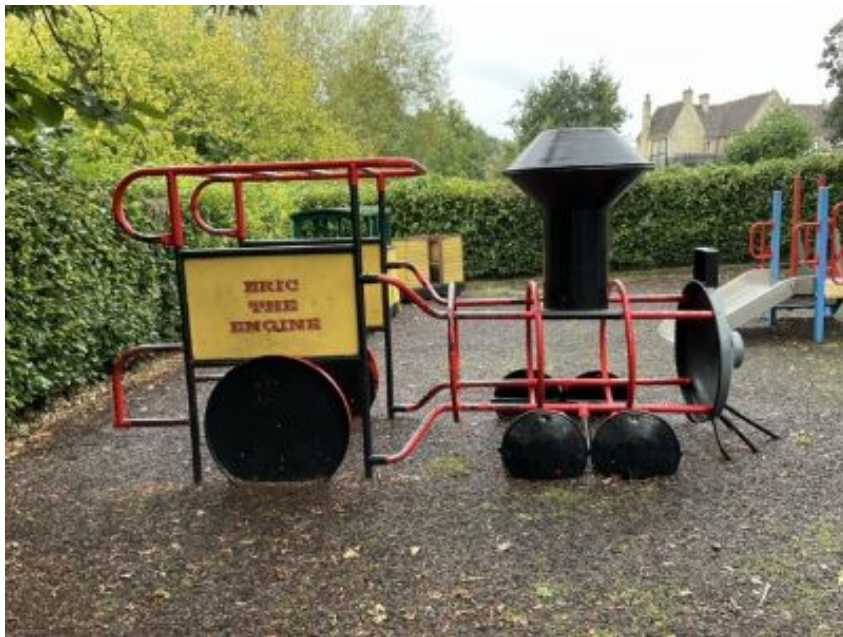
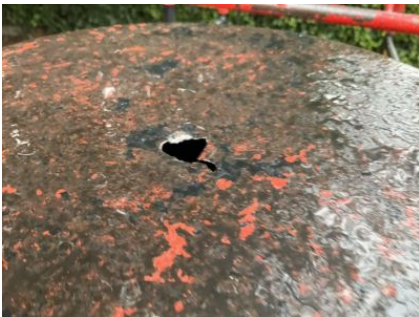
Climber - Train

Item has some parts missing.

Replace the missing parts.

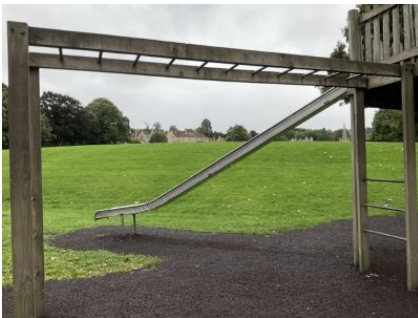
Timber is decayed.

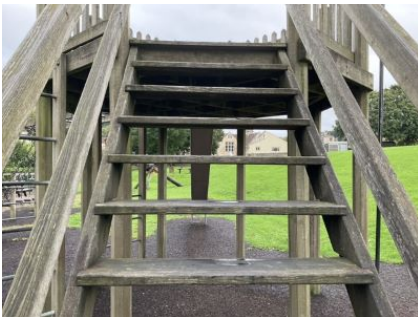
Access fails the entrapment requirements.

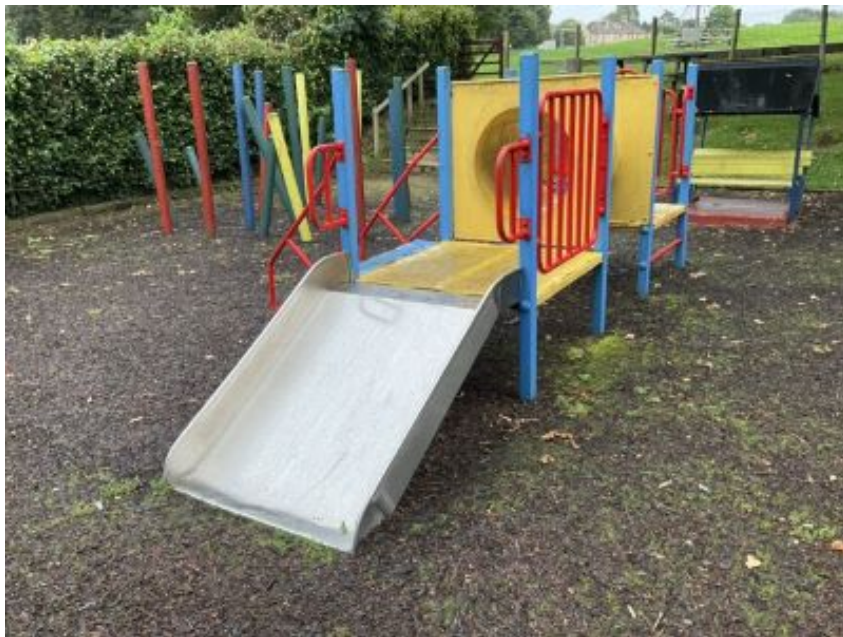
Multiplay - Toddler

Item has corrosion.

The blue steps are very corroded with sharp edges underneath. Movement in the steps. Corrosion in the frame. The repair does not support the step.

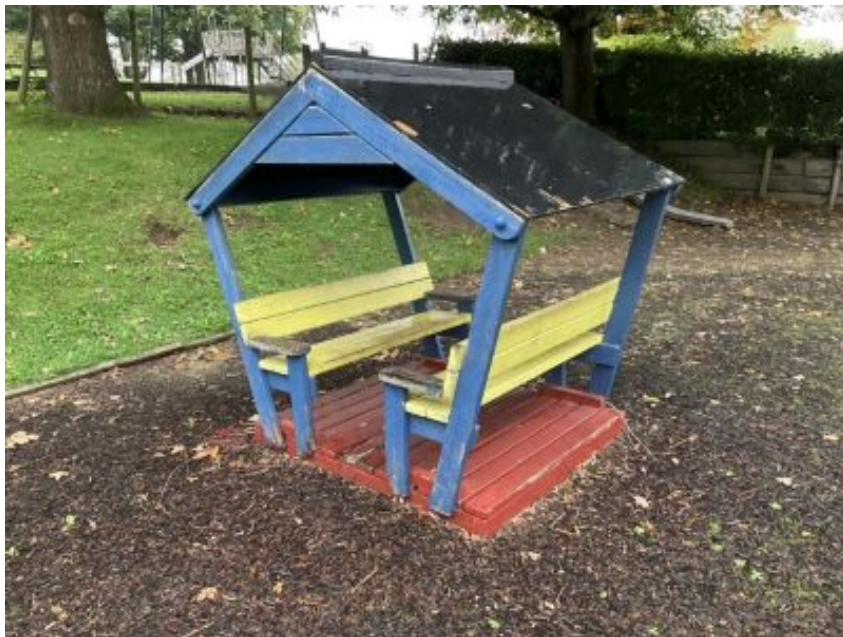
Play Hut

Minor repairs are needed.

Repair.

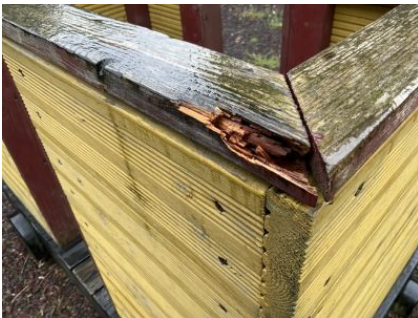
Timber is decayed.

Replace affected parts.

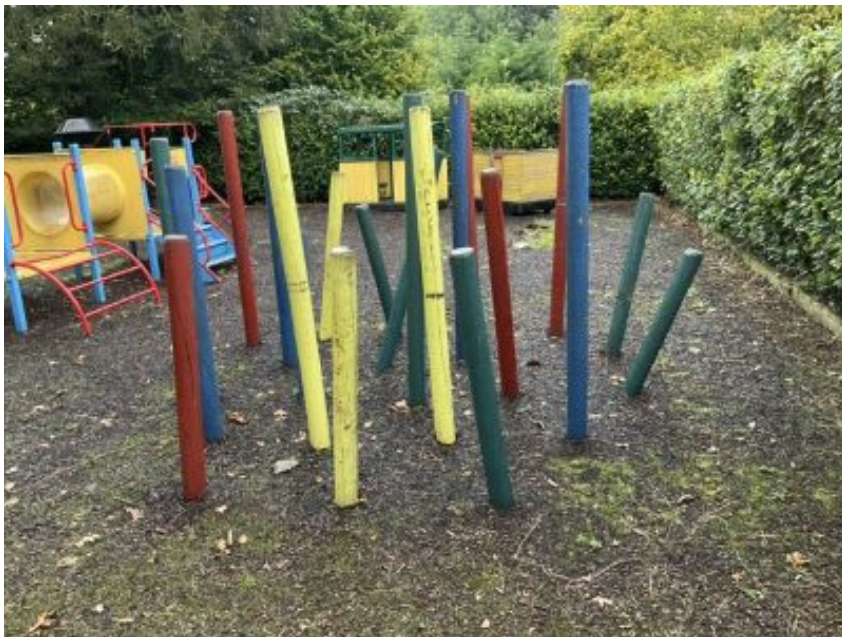
Weave Posts - Pole Maze

Loose in ground.

Some poles are loose but at the time of the inspection could no longer be pulled out of their holes. Monitor.

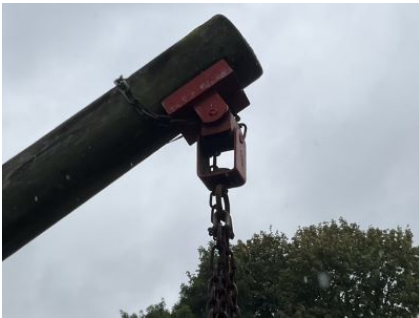
Fixtures loose or missing.

Replace.

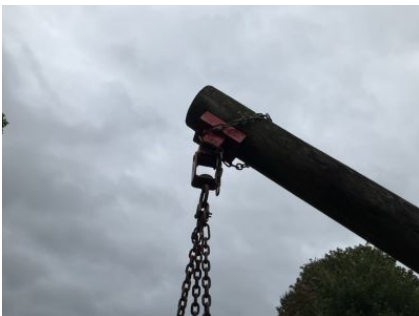
Item is damaged.

Replace.

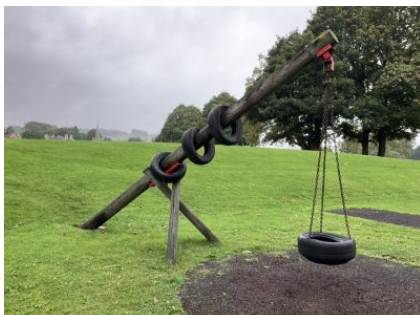
Timber is decayed.

Soft spots in air cracks.

We recommend resistograph testing to determine the internal condition of the timber. We can undertake this testing at additional cost. Please contact us for details.

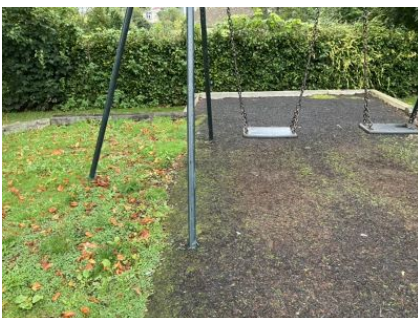
Swing - Mixed - 1 Bay 1 Junior 1 Toddler Seat

Some chain wear.

Monitor for further deterioration and replace before 40% wear.

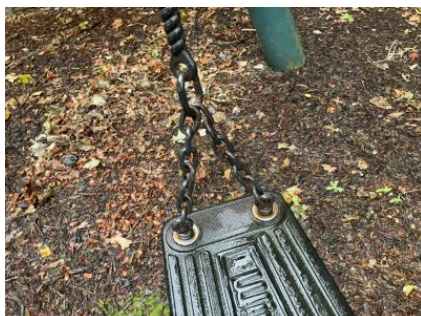
Swing - Mixed - 1 Bay 2 Junior 2 Toddler Seat

There is wear in the bushes.

Remove shackle bolt and check bush and shackle pin wear, replacing as necessary.
